<b>Make:</b> Ford	<b>Model:</b> Transit	<b>Body Style:</b> Van
<b>Year:</b> 2012	<b>Registration:</b> GJM132	<b>Reg Expiry:</b> 27 Aug 2019
<b>WoF Expiry:</b> 22 May 2020	<b>Odometer:</b> 232,190 Kms	<b>Good No:</b> 19501084
<b>VIN:</b> WF0XXXTFXC5399C	<b>Next Service:</b> 250,000kms	<b>Service History:</b> No

**Body Inspection Comments**

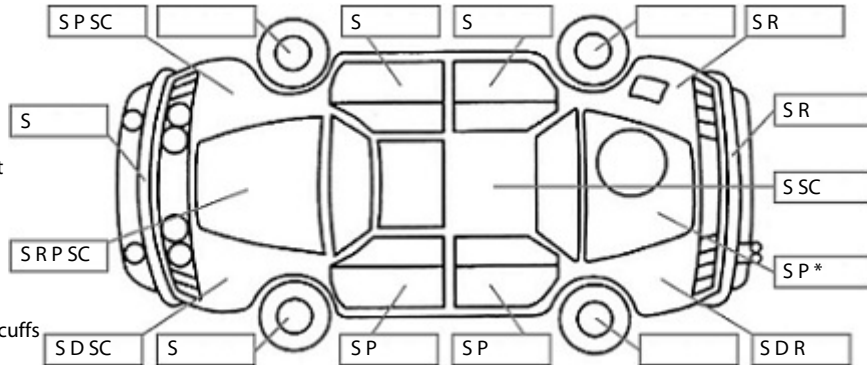
- S = scratch
- D = dent
- R = rust
- PT = paint defect
- C = crack
- P = pin dent
- \* = decals
- SC = stone chips
- W = significant scuffs

Note: some defects &amp; blemishes may not be displayed in the diagram

- Adjustment handles on side of drivers seat are missing.
- Stone chips in windscreen.
- Number plate light cover is missing.
- Plastic Trim under petrol flap is missing.
- Plastic centre cap is missing off left front & right rear wheels.
