<b>Make:</b>	Toyota	<b>Model:</b>	Liteace	<b>Body Style:</b>	Van
<b>Year:</b>	1997	<b>Registration:</b>	BZH665	<b>Reg Expiry:</b>	07 Apr 2020
<b>WoF Expiry:</b>	15 Oct 2019	<b>Odometer:</b>	304,739 Kms	<b>Good No:</b>	19513592
<b>VIN:</b>	7A8H60J0704007246	<b>Next Service:</b>	313,647kms	<b>Service History:</b>	No

## Body Inspection Comments

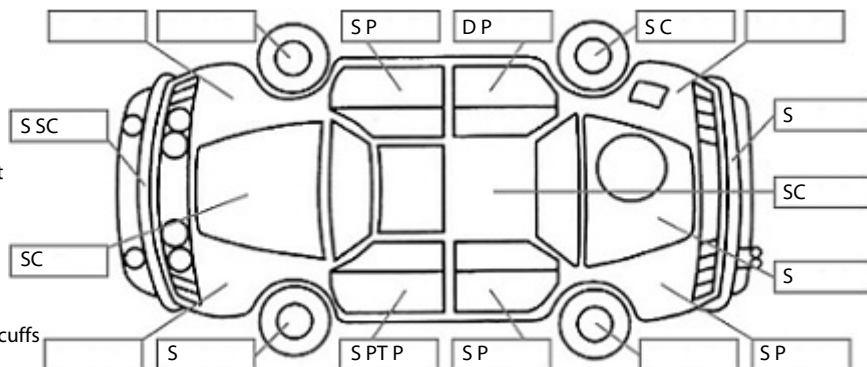
S = scratch  
D = dent  
R = rust  
PT = paint defect  
C = crack  
P = pin dent  
\* = decals  
SC = stone chips  
W = significant scuffs

Note: some defects & blemishes may not be displayed in the diagram

Interior door lights on both front doors are not working & lenses have broken off. Missing right front wheel hub cap. Stone chips in windscreen.
