Make:	Isuzu	Model:	Bighorn	Body Style:	Wagon
Year:	1993	Registration:	CWY783	Reg Expiry:	30 Jun 2020
WoF Expiry:	19 Sep 2019	Odometer:	235,760 Kms	Good No:	19516840
VIN:	7A897130705208863	Next Service:	236833	Service History:	No

Body Inspection Comments

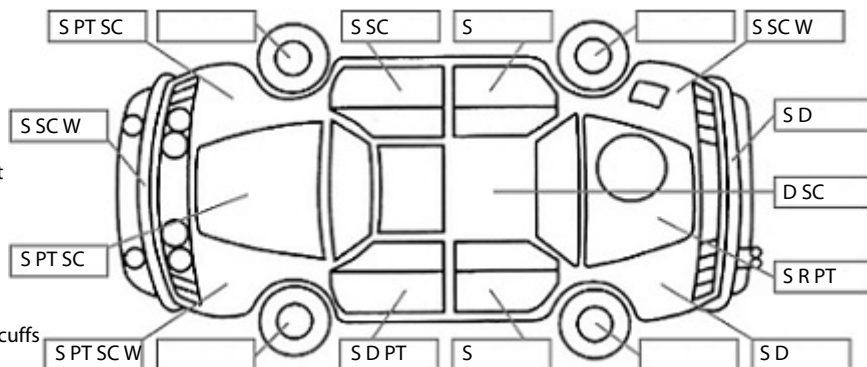
Spotlights and RH number plate lamp not going. Parking mirror missing on LF guard. Clearcoat is coming off vehicle. Rust on door weatherstrips. Vent missing LR guard. Roof spoiler panel missing. Rust spot on small back door by catch. Stonechips on windscreen. Damage on LR door card. Wear on RF seat
