| <b>Make:</b> | Ford | <b>Model:</b> | Ecosport | <b>Body Style:</b> | SUV |
| <b>Year:</b> | 2014 | <b>Registration:</b> | HSU914 | <b>Reg Expiry:</b> | 04 Nov 2019 |

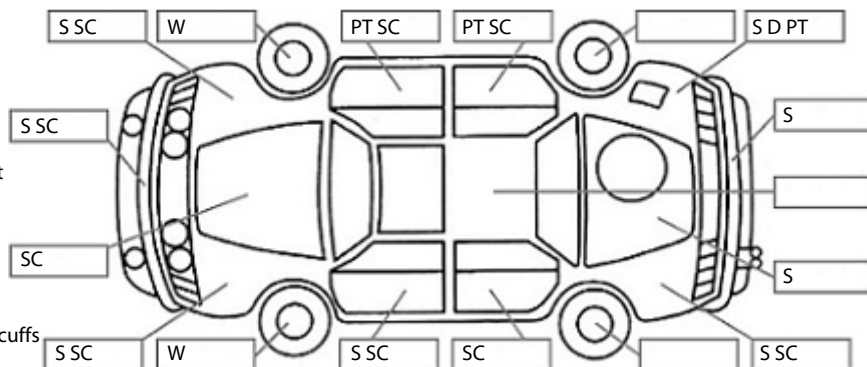
**Body Inspection Comments**

Suntan lotion damage on paint. Stonechips on windscreen. Aerial missing. LR and RF seatbelts have wear.

Note: some defects & blemishes may not be displayed in the diagram
