| Make: Nissan | Model: Note | Body Style: Hatchback |
| Year: 2005 | Registration: HYD155 | Reg Expiry: 16 Jul 2019 |

Body Inspection Comments

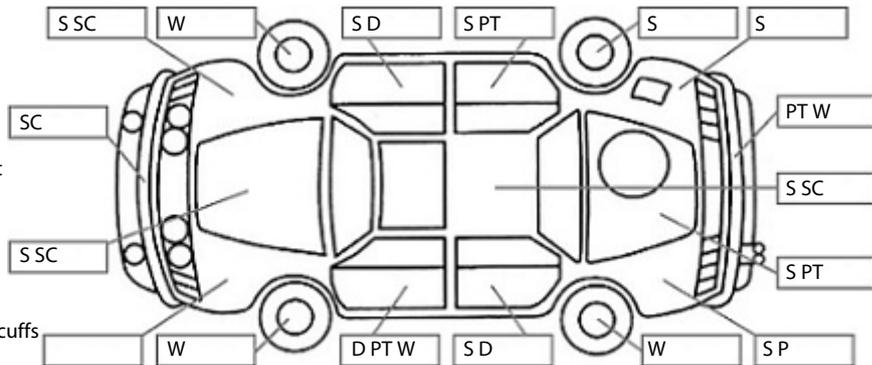
Note: some defects & blemishes may not be displayed in the diagram

Headlights dull
 Front end misaligned
 Tailgate outside handle loose
 Front windscreen rubber seal loose
