Make:	Subaru	Model:	Impreza	Body Style:	Wagon
Year:	1993	Registration:	ZB1940	Reg Expiry:	03 Mar 2020
WoF Expiry:	24 Oct 2019	Odometer:	210,725 Kms	Good No:	19524189
VIN:	7A8GF090700007180	Next Service:	206,000kms	Service History:	No

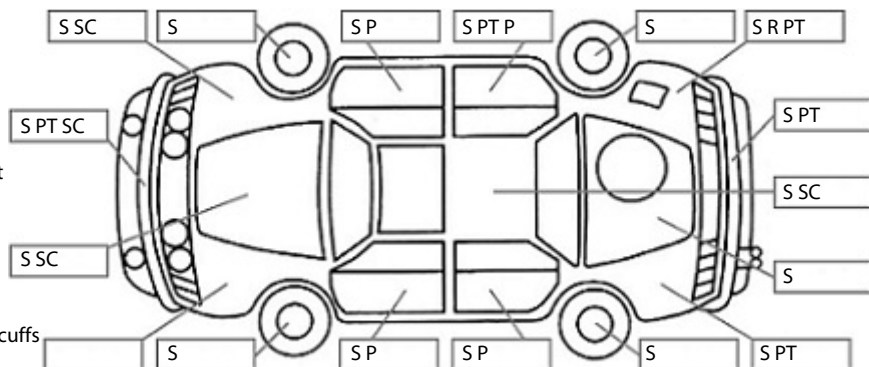
Front of right side monsoon shield is broken off. Stone chips in windscreen. Paint work clear coat is lifting off front bumper, left rear guard, rear bumper, right rear guard & right rear door.
