| Make: | Ford | Model: | Escape | Body Style: | SUV |
| Year: | 2002 | Registration: | ARG211 | Reg Expiry: | 01 Oct 2019 |
| VIN: | JC0YU041821105331 | Next Service: | 278069 | Service History: | No |

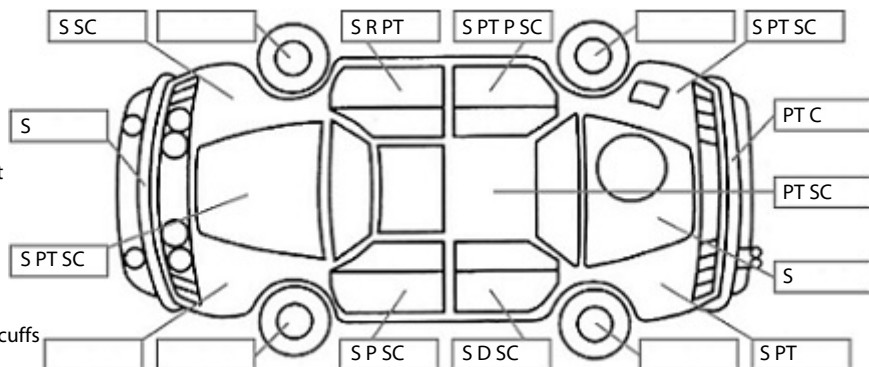
S = scratch
D = dent
R = rust
PT = paint defect
C = crack
P = pin dent
* = decals
SC = stone chips
W = significant scuffs

Note: some defects & blemishes may not be displayed in the diagram

RH number plate lamp not going. LF door body rubber damaged. LR door not opening from outer handle. Paint damage on body trims and rear bumper. Speaker and mic holder screwed to console and dash. Wear on steering wheel. Damage on console lid. No jack or tools. Boot area has marks.
