<b>Make:</b>	Ford	<b>Model:</b>	Territory	<b>Body Style:</b>	Wagon
<b>Year:</b>	2005	<b>Registration:</b>	HPL662	<b>Reg Expiry:</b>	21 Aug 2019
<b>WoF Expiry:</b>	16 Oct 2019	<b>Odometer:</b>	207,710 Kms	<b>Good No:</b>	19600212
<b>VIN:</b>	6FPAAJGAT4E51994	<b>Next Service:</b>		<b>Service History:</b>	No

## Body Inspection Comments

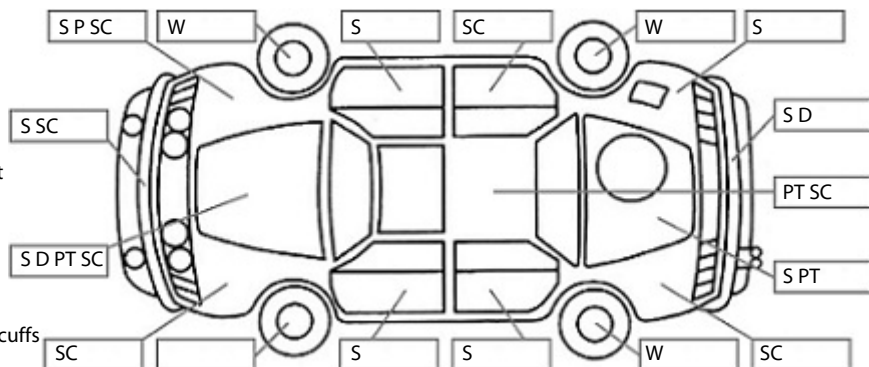
Note: some defects & blemishes may not be displayed in the diagram

Wiper mechanism is worn. RH low beam not going. Headlamps need buffing. LF and RR center caps missing. Clearcoat is coming off vehicle. Number plate lamp holder is cracked. Lid on top of dash is damaged. Catch on console lid broken. Gear lever knob worn. LF window not working. AC not cold.
