<b>Make:</b>	Nissan	<b>Model:</b>	Teana	<b>Body Style:</b>	Sedan
<b>Year:</b>	2004	<b>Registration:</b>	GY505	<b>Reg Expiry:</b>	27 Dec 2019
<b>WoF Expiry:</b>	16 Feb 2020	<b>Odometer:</b>	141,647 Kms	<b>Good No:</b>	19626533
<b>VIN:</b>	7AT0DH71X13101347	<b>Next Service:</b>		<b>Service History:</b>	No

**Body Inspection Comments**

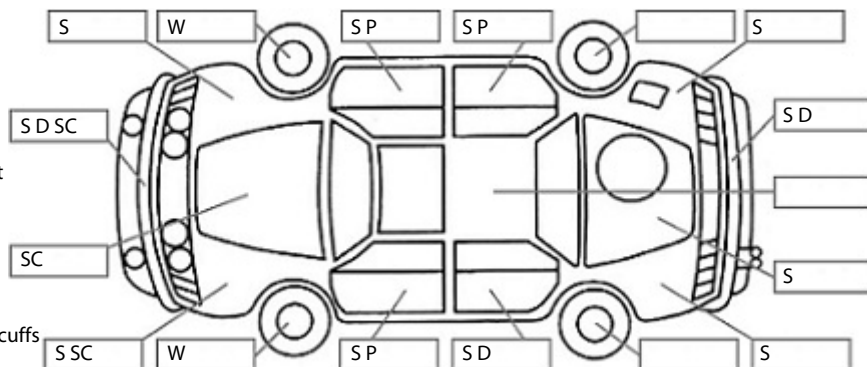
RH indicator repeater lamp has moisture. LH mirror body broken. LR wheel center cap missing. Stonechips on windscreen.  
Park brake light not working in dash. 2x RH air vents in dash are damaged. Wear on seat cloth, all seats.
