| Make: | Honda | Model: | CRV | Body Style: | SUV |
| Year: | 2002 | Registration: | FTZ668 | Reg Expiry: | 27 Jan 2020 |

Note: This report is not a warranty

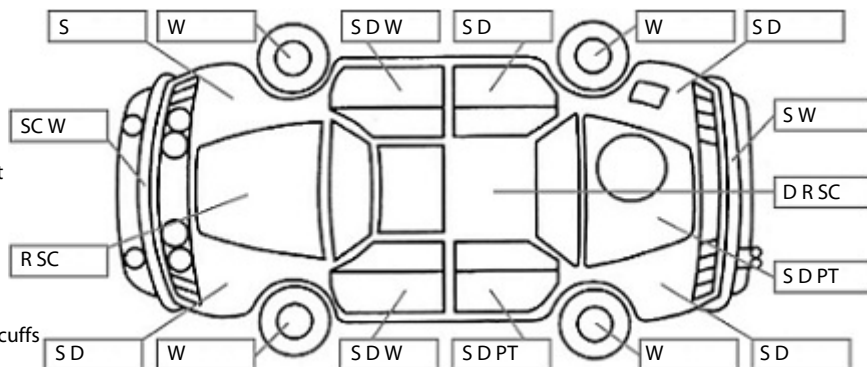
S = scratch
D = dent
R = rust
PT = paint defect
C = crack
P = pin dent
* = decals
SC = stone chips
W = significant scuffs

Note: some defects & blemishes may not be displayed in the diagram

All monsoons loose
Right drip rail rust
Left front fender alignment
