| <b>Make:</b> | Nissan | <b>Model:</b> | Tino | <b>Body Style:</b> | Wagon |
| <b>Year:</b> | 1999 | <b>Registration:</b> | EPE24 | <b>Reg Expiry:</b> | 08 Jul 2020 |

**Body Inspection Comments**

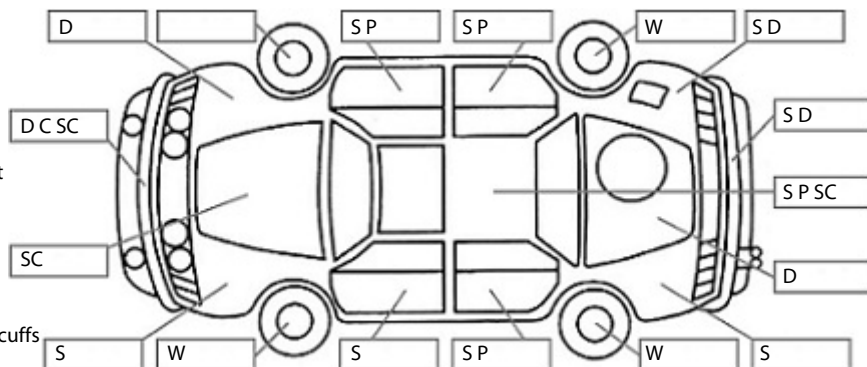
S = scratch  
D = dent  
R = rust  
PT = paint defect  
C = crack  
P = pin dent  
\* = decals  
SC = stone chips  
W = significant scuffs

Aerial mast Broken, R/F Seat Belt slow to Retract.

Note: some defects & blemishes may not be displayed in the diagram
