| Make: | Holden | Model: | UTE | Body Style: | Utility |
| Year: | 2002 | Registration: | JHA988 | Reg Expiry: | 07 Feb 2020 |

Body Inspection Comments

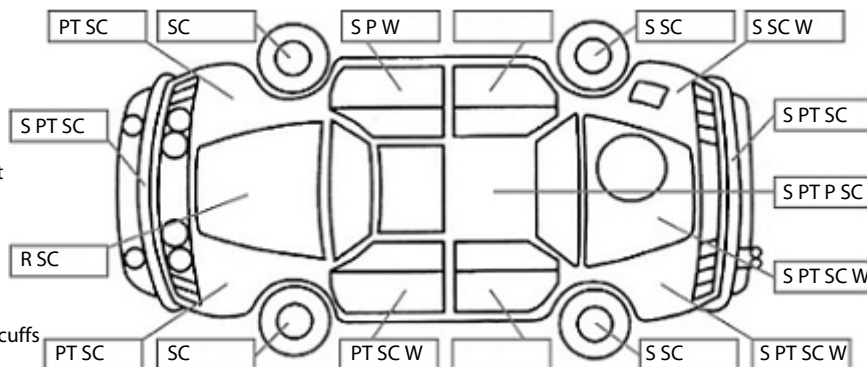
Clear coat coming off front bumper left front guard, left front door, the roof, the canopy, left rear quarter, cracks in the paint on the right front guard, front bumper, rear bumper, aerial is bent,
