Basic Vehicle Condition Guide

Report ID: 19,992,334

Make: Model: Toyota Hilux **Body Style:** Utility Year: 2014 Registration: HUC713 Reg Expiry: 15 Mar 2020 **Odometer:** WoF Expiry: 22 Nov 2020 170,292 Kms **Good No:** 19992334 VIN: MR0EZ12G804014587 Next Service: Service History:

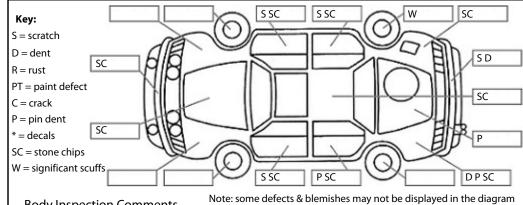
Body Inspection Comments

Rubber trim coming off lower edge of canopy both sides. Trailer electrical coupling not secure. Has jack but no tools. Stonechips on windscreen.
