| Make: | Mazda | Model: | Familia | Body Style: | Wagon |
| Year: | 2001 | Registration: | FKH968 | Reg Expiry: | 01 Jul 2020 |

Body Inspection Comments

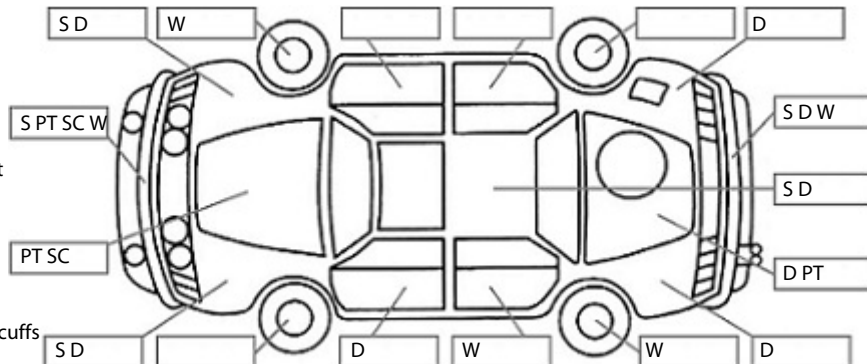
S = scratch
D = dent
R = rust
PT = paint defect
C = crack
P = pin dent
* = decals
SC = stone chips
W = significant scuffs

Right rear tail light lens cracked
Possibly wof issue with dent in right rear quarter

Note: some defects & blemishes may not be displayed in the diagram
