| Make: | Mazda | Model: | Tribute | Body Style: | SUV |
| Year: | 2005 | Registration: | CLL803 | Reg Expiry: | 20 Dec 2020 |

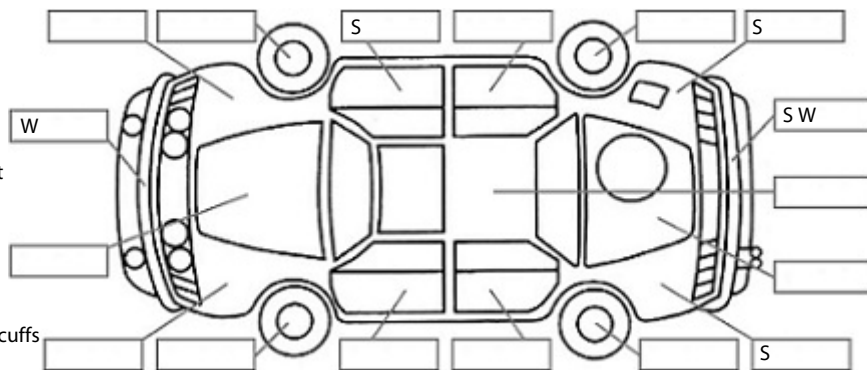
Body Inspection Comments

Note: some defects & blemishes may not be displayed in the diagram

Conditions During Body Inspection: Dry
