<b>Make:</b>	Hyundai	<b>Model:</b>	I30	<b>Body Style:</b>	Wagon
<b>Year:</b>	2011	<b>Registration:</b>	GDC512	<b>Reg Expiry:</b>	25 Oct 2024
<b>WoF Expiry:</b>		<b>Odometer:</b>	236,634 Kms	<b>Good No:</b>	22955415
<b>VIN:</b>	KMHDC81SMCU13514	<b>Next Service:</b>	243,000kms	<b>Service History:</b>	Yes

**Body Inspection Comments**

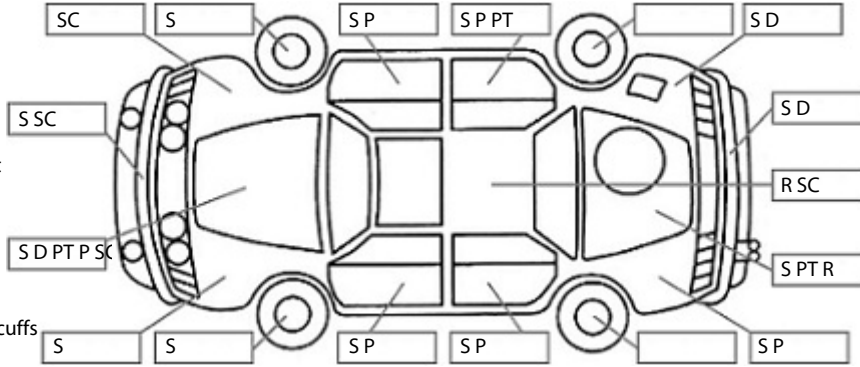
Small stone crack in left side of windscreen. Dents in right & left side sills, one under drivers door & one under left front door.
