<b>Make:</b>	Toyota	<b>Model:</b>	Hiace	<b>Body Style:</b>	Van
<b>Year:</b>	2018	<b>Registration:</b>	1DELVR	<b>Reg Expiry:</b>	11 Jul 2025
<b>WoF Expiry:</b>	04 Sep 2025	<b>Odometer:</b>	448,137 Kms	<b>Good No:</b>	22985630
<b>VIN:</b>	JTFPT22PX00019903	<b>Next Service:</b>	377,186 Kms	<b>Service History:</b>	No

## Body Inspection Comments

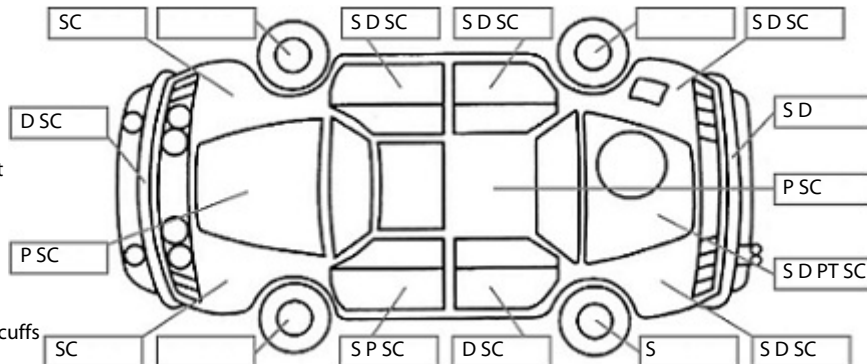
Stonechip/crack in windscreen. Tailgate doesn't open.  
Bullbar dented/pushed in. Rear Toyota badge missing.  
RH taillight damaged. RH side wheels missing centre caps.

LH sill dented.
