Report ID:	24,876,202	Version:	2
Created:	24 Mar 2026

Make:	Hyundai	Model:	Staria Load
Body Style:	Van	Year:	2022
Rego No.:	PPA199	Rego Expiry:	21 May 2026
WoF Expiry:	02 Dec 2026	Odometer:	177,416 Kms
Good No.:	24876202	VIN:	KMFYFX71MNU078499
Next Service:	190,000kms	Service History:	No

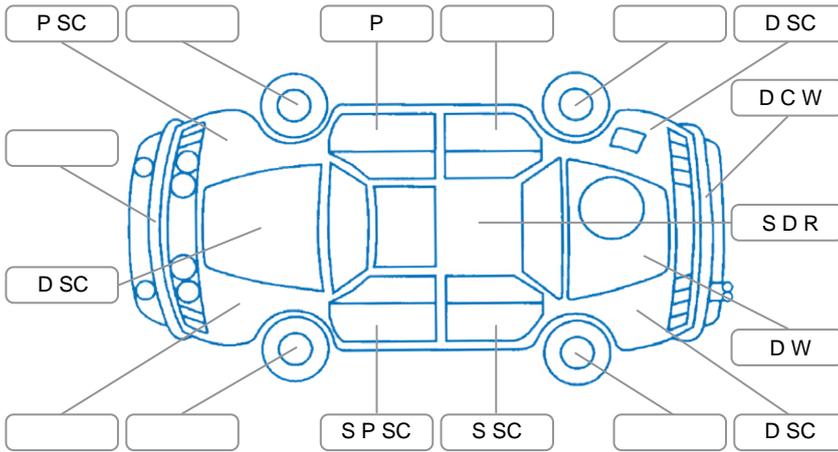
Note: some defects and blemishes may not be displayed in the diagram

Bolt anchors and holes in roof gutters for roof rack base. (Not sealed properly). After market rear step is bent. Numbers of minor dents on bonnet. Minor dents on both side A pillars. Rear badge and decal are missing. Scuff and dents in cargo area.
