Report ID:	24,876,633	Version:	1
Created:	15 Apr 2026

Make:	Holden	Model:	Equinox
Body Style:	SUV	Year:	2020
Rego No.:	NEM623	Rego Expiry:	02 Dec 2026
WoF Expiry:	18 Dec 2026	Odometer:	183,767 Kms
Good No.:	24876633	VIN:	3G0AX7EX1LS687787
Next Service:	197,000km's	Service History:	No

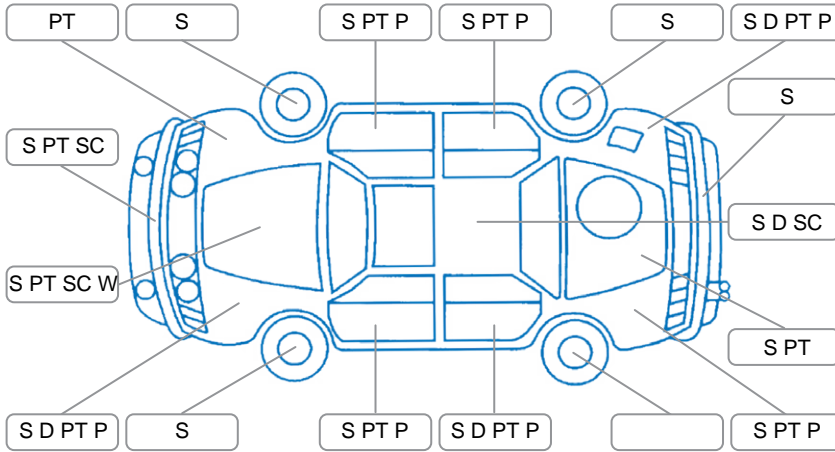
Holes in left and right side corners on front & rear bumpers. Rubber dome with wires in it fitted to roof panel, they were the wires that went to light bar. Two R/T aerial bases fitted to roof panel. Three bolt holes in left front foot well area.
