Report ID:	24,876,890	Version:	2
Created:	28 Apr 2026

Make:	Holden	Model:	Commodore
Body Style:	Wagon	Year:	2020
Rego No.:	MTE601	Rego Expiry:	11 Mar 2027
WoF Expiry:	07 Apr 2027	Odometer:	188,411 Kms
Good No.:	24876890	VIN:	W0VZM8EC7L1009019
Next Service:	190,000km's	Service History:	No

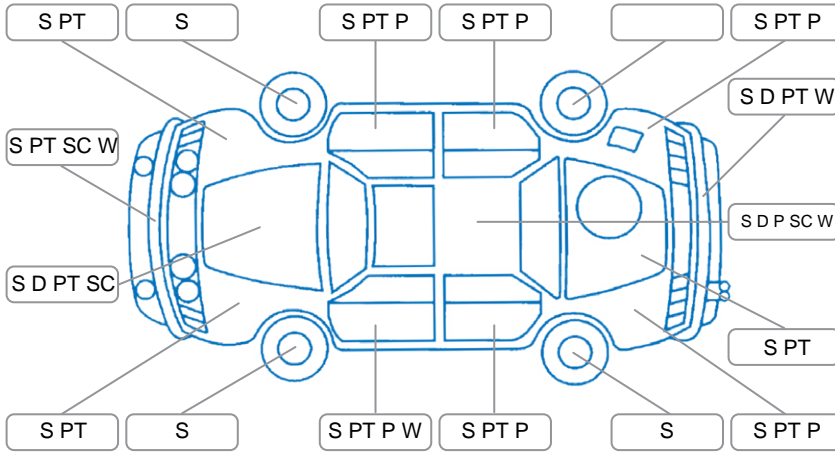
Note: some defects and blemishes may not be displayed in the diagram

Holes in all corners of front and rear bumpers. Rubber grommet/dome & four R/T aerial base fitted to roof panel. Chrome trim broken on right side of rear bumper. Small dent in right side sill & small dent in left side sill, under both front doors.
