Report ID:	24,877,564	Version:	2
Created:	29 May 2026

Make:	Mazda	Model:	Bt-50
Body Style:	Utility	Year:	2018
Rego No.:	LQE879	Rego Expiry:	26 Sep 2026
WoF Expiry:	08 Jun 2027	Odometer:	187,448 Kms
Good No.:	24877564	VIN:	MMOUR0YG100840708
Next Service:	?	Service History:	No

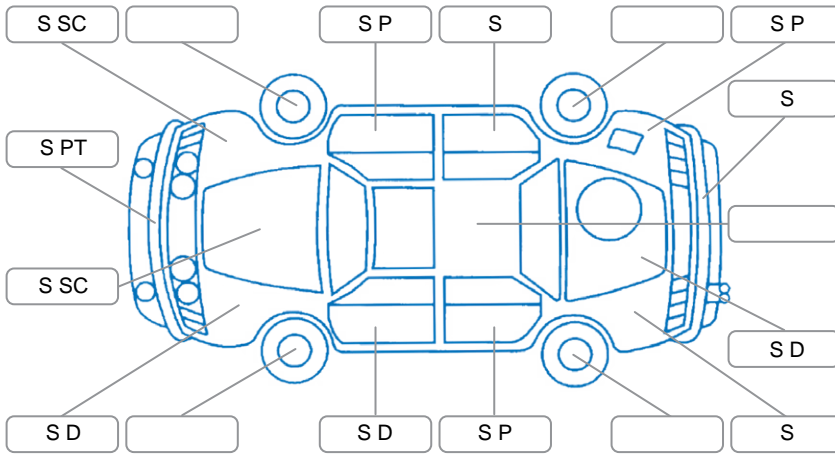
Holes on inside lip of both front guard, where aerial brackets have been fitted. Dent in bottom rear edge of left front guard. Small stone crack in middle of windscreen. Paint flaking off front bumper. Left front spot light blank is missing out of front bumper. Rear bumper has been pushed into deck.
