| Report ID: | 24,878,183 | Version: | 1 |

| Make: | Mitsubishi | Model: | Eclipse Cross |
| Body Style: | SUV | Year: | 2022 |

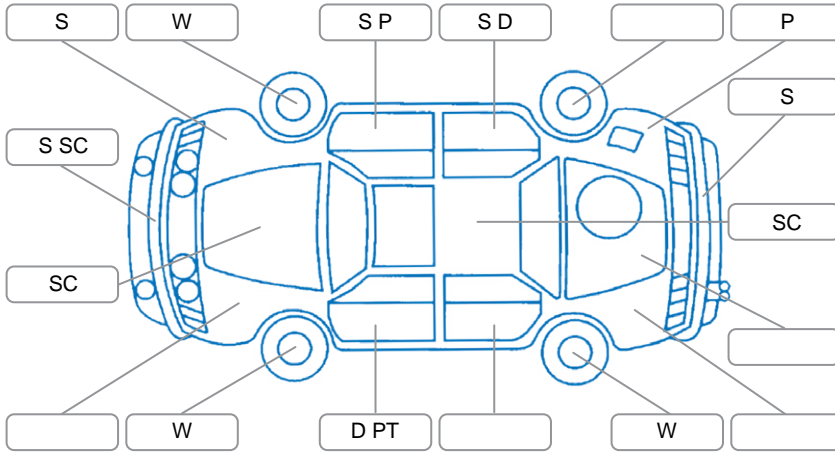
S = Scratch R = Rust C = Crack * = Decals W = Significant scuffs
 D = Dent PT = Paint defect P = Pin dent SC = Stone Chips

Note: some defects and blemishes may not be displayed in the diagram

Service is over due. RUC is expired. Both door mirror covers are scratched. Side wall of left front, left rear tyres are damaged (replacement required). EV charger is missing (only fast charge cable is supplied). Factory Run-flat kit in boot.
