| Report ID: | 24,878,424 | Version: | 1 |

| Make: | Mazda | Model: | Bt-50 |
| Body Style: | Utility | Year: | 2018 |

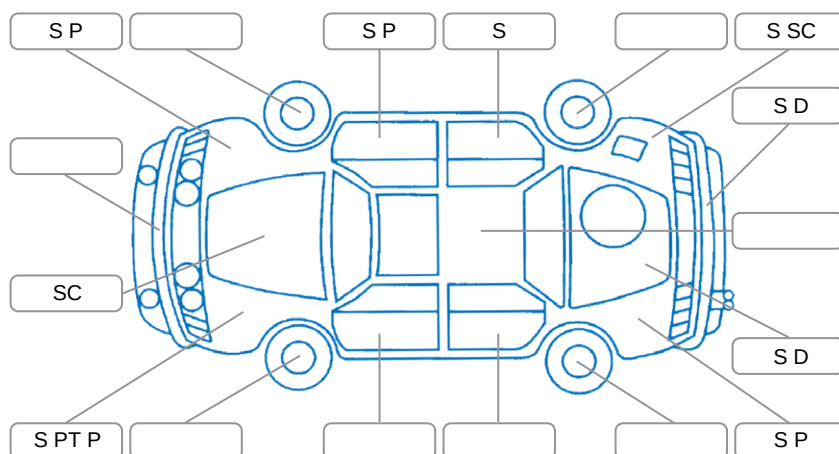
S = Scratch    R = Rust    C = Crack    \* = Decals    W = Significant scuffs  
D = Dent    PT = Paint defect    P = Pin dent    SC = Stone Chips

Note: some defects and blemishes may not be displayed in the diagram

Small stone crack in left side of windshield. Canopy spoiler is badly cracked. Right front door seal rubber is worn, torn. Rear bumper alignment required. Both sill paint is worn. Right headlight clear coat is fading.
