| Report ID: | 24,879,087 | Version: | 2 |

| Make: | Mazda | Model: | Bt-50 |
| Body Style: | Utility | Year: | 2018 |

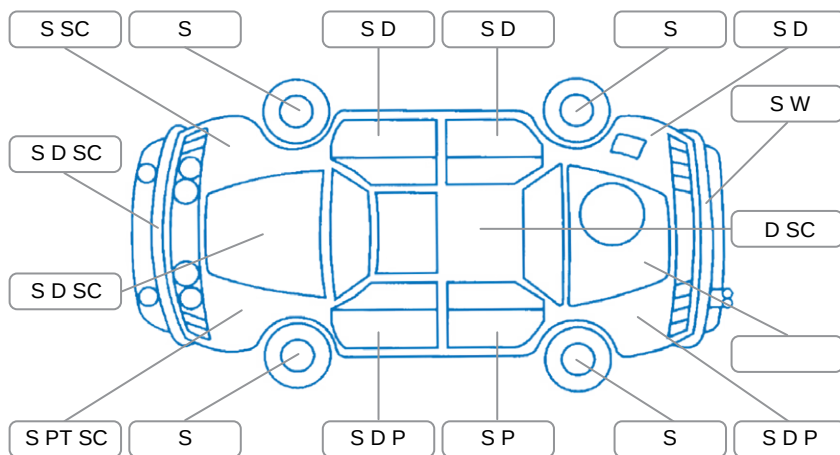
Note: some defects and blemishes may not be displayed in the diagram

Cracks in right rear taillight lens, water inside lens. Missing left rear mud flap. Dents along left & right side sills. Dent in left side of front bumper has deformed plastic, bumper out of shape. Inside edge on right front tyre is worn, tyre needs replaced.
