# **Basic Condition Guide**

Report ID: 25,004,118		Version:	3
Created:	17 Dec 2025

Make:	Subaru	Model:	Impreza		
Body Style:	Hatchback	Year:	2012		
Rego No.:	QKM171	Rego Expiry:	14 Feb 2026		
WoF Expiry:	18 Mar 2026	Odometer:	151,185 Kms		
Good No.:	25004118	VIN:	7AT0GF09X23008840		
Next Service:	154,000 Kms	Service History:	Yes		
Note: This report is not a warranty

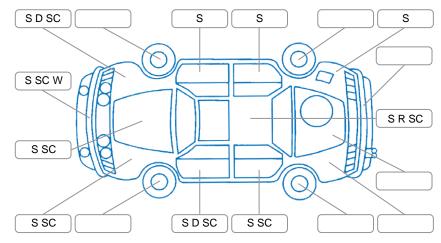
ĸey				
S = Scratch	R = Rust	C = Crack	* = Decals	W = Significant scuffs
D = Dent	PT = Paint defect	P = Pin dent	SC = Stone Chips

Note: some defects and blemishes may not be displayed in the diagram  $\,$
