| Make: | Mitsubishi | Model: | Triton | Body Style: | Utility |
| Year: | 2017 | Registration: | KUE695 | Reg Expiry: | 24 May 2024 |

Body Inspection Comments

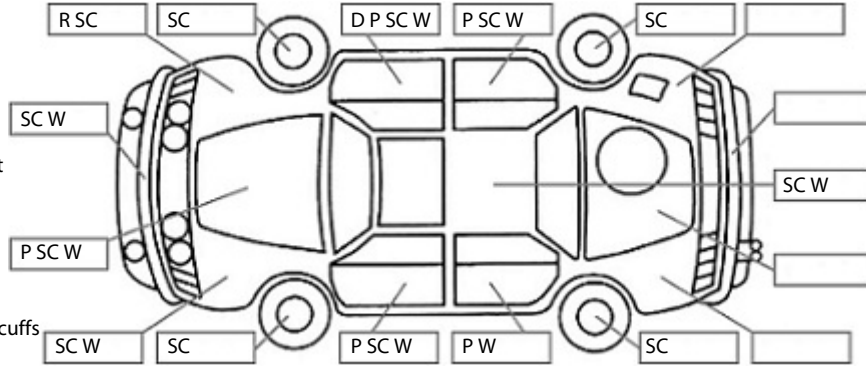
Note: some defects & blemishes may not be displayed in the diagram

Front screen broken
RF guard loose, rattling
Steering wheel wrap worn
Interior roof storage compartment lid broken
