| Make: | Holden | Model: | Cruze | Body Style: | Hatchback |
| Year: | 2012 | Registration: | GLA483 | Reg Expiry: | 14 May 2024 |

Body Inspection Comments

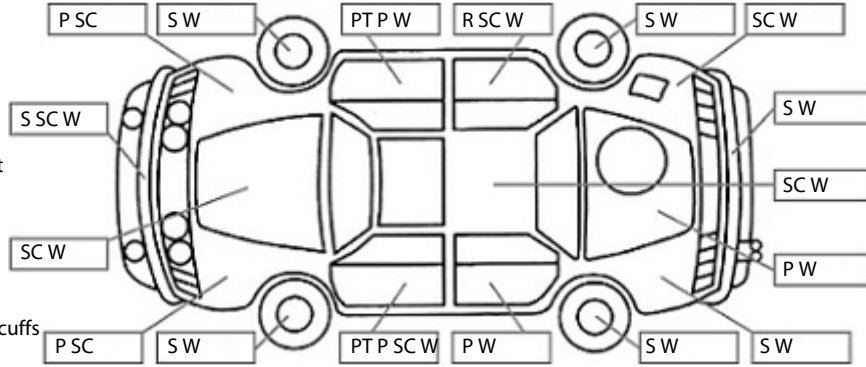
S = scratch
D = dent
R = rust
PT = paint defect
C = crack
P = pin dent
* = decals
SC = stone chips
W = significant scuffs

Note: some defects & blemishes may not be displayed in the diagram

LF tyre looks flat
Chips front screen
Scuffing front bumper lip
Paint defect/fade both sides wing mirror scalp & base
Rust along bottom edge interior RR door
