Basic Vehicle Condition Guide

Make: Model: Mitsubishi L300 **Body Style:** Van Year: 2010 Registration: FLA493 **Reg Expiry:** 16 Jul 2024 WoF Expiry: **Odometer:** 220,770 Kms **Good No:** 25675247 VIN: JMASNP04VAA800355 Next Service: no service history Service History:

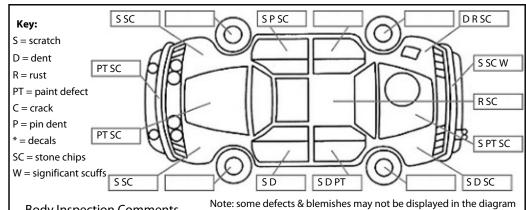
Body Inspection Comments

Lh side of vehicle has damage. Lh slider door damaged. Rust in roof gutters. Slider door window rubber poor fit. Rh indicator lense broken. Rh head light has cracks. Lh side light has hole
