| Report ID: | 25,914,893 | Version: | 1 |

| Make: | Ford | Model: | Ranger |
| Body Style: | Utility | Year: | 2019 |

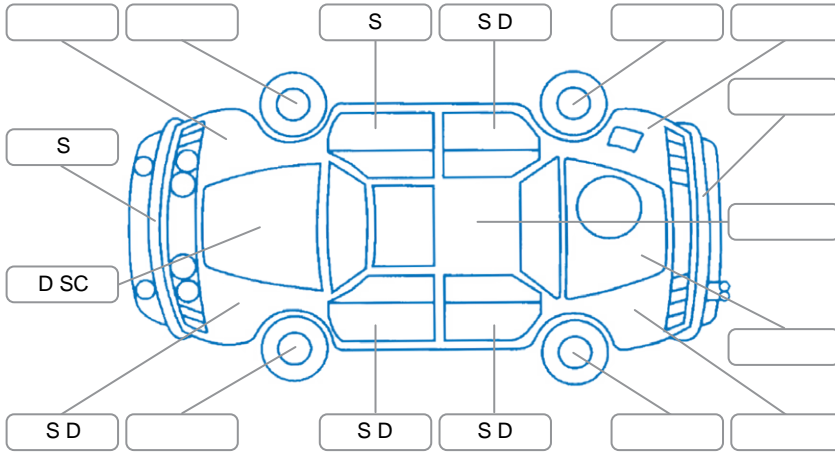
S = Scratch R = Rust C = Crack * = Decals W = Significant scuffs
 D = Dent PT = Paint defect P = Pin dent SC = Stone Chips

Note: some defects and blemishes may not be displayed in the diagram

Hood lining not secure. Roof rack key mis. One remote key crack.
 LF wheel hub cap mis. RF body seat torn. Windscreen crack in CVA.
