Report ID:	25,948,991	Version:	1
Created:	16 Apr 2026

Make:	Mazda	Model:	CX-5
Body Style:	Wagon	Year:	2013
Rego No.:	QFT671	Rego Expiry:	01 Jan 2026
WoF Expiry:	02 Oct 2026	Odometer:	146,567 Kms
Good No.:	25948991	VIN:	7AT0C144X23120132
Next Service:	137,108 kms	Service History:	No

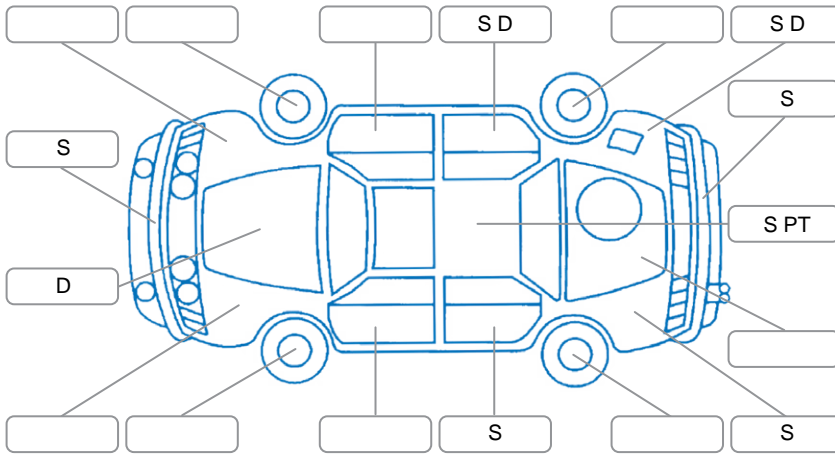
Note: some defects and blemishes may not be displayed in the diagram

R tail light damage, interior panel missing parts parts, both front lower arm bushes split, L front tyre cracked,
