•	Report ID:	25,960,013	Version:	2
	Created:	04 Nov 2025

Body Inspection Comments

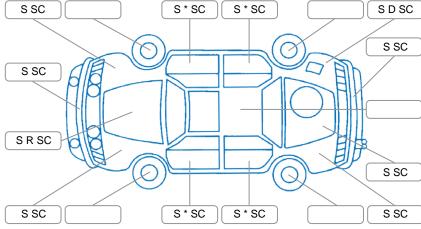
Note: some defects and blemishes may not be displayed in the diagram

Right and left kick boards gouged/orange lights fitted/aircon blow hot/hole in dash from rtrot
