•	Report ID:	25,961,134	Version:	1
	Created:	01 Dec 2025

Make:	Toyota	Model:	Rav4
Body Style:	suv	Year:	2022
Rego No.:	PGT887	Rego Expiry:	30 Mar 2026
WoF Expiry:	10 Jan 2026	Odometer:	87,448 Kms
Good No.:	25961134	VIN:	JTMZ43FV50D124578
Next Service:	90411	Service History:	Yes

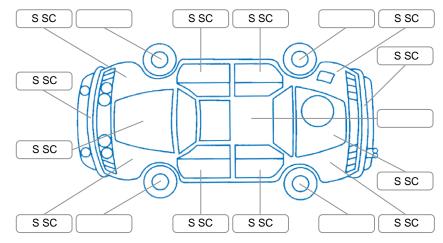
Note: some defects and blemishes may not be displayed in the diagram

Crack in cva/fr tyre major inner edge wear tyre needs replacing/rear tyres inner edge
