| Make: | Volkswagen | Model: | Tiguan |
| Body Style: | SUV | Year: | 2018 |

This report is a guide only. Consideration is made for age and mileage. Parts have not been dismantled or diagnostic testing undertaken. The vehicle has been driven up to 50km/h from cold. The Vendor recommends a full mechanical inspection prior to purchase and this can be arranged for an additional charge.

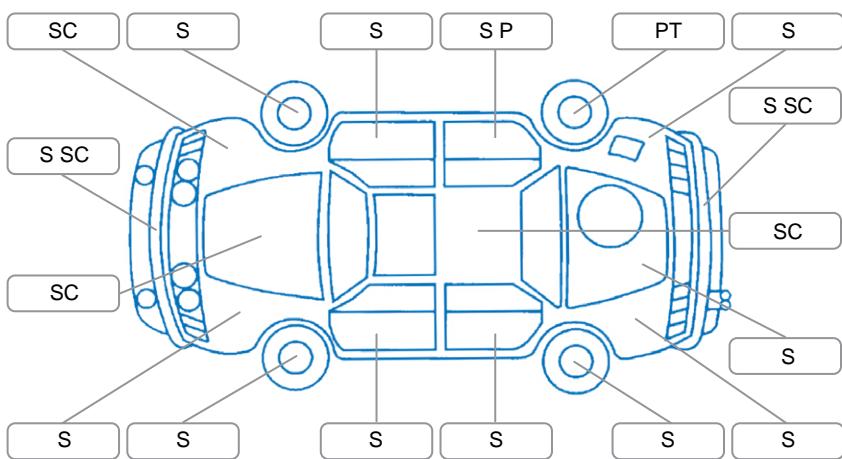
S = Scratch    R = Rust    C = Crack    \* = Decals    W = Significant scuffs  
 D = Dent    PT = Paint defect    P = Pin dent    SC = Stone Chips

Note: some defects and blemishes may not be displayed in the diagram

Stone chips in the windscreens one has legs,
