<b>Make:</b>	Hyundai	<b>Model:</b>	Santa FE	<b>Body Style:</b>	SUV
<b>Year:</b>	2021	<b>Registration:</b>	NJQ836	<b>Reg Expiry:</b>	24 Jun 2025
<b>WoF Expiry:</b>	26 Mar 2026	<b>Odometer:</b>	200,107 Kms	<b>Good No:</b>	26044560
<b>VIN:</b>	KMH5281HWMU367683	<b>Next Service:</b>	200,000kms	<b>Service History:</b>	Yes

**Body Inspection Comments**

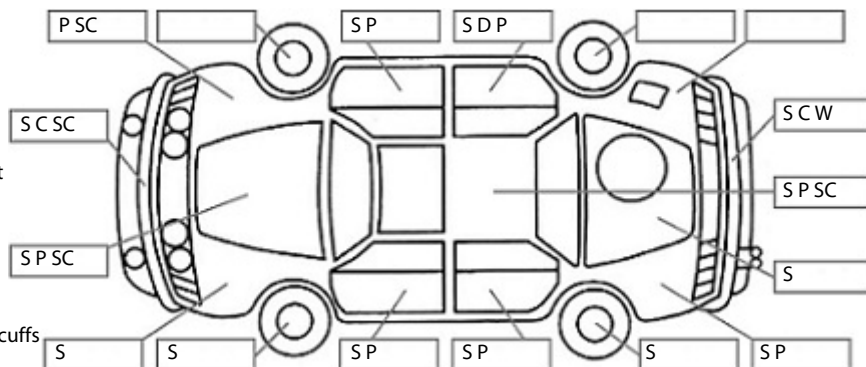
Large cracks in front & rear bumpers. Dents & scratches on left rear inner wheel arch, inside of left rear door frame. Three small stone cracks in windscreen & two poor stone chip repairs, one of poor repairs are in right side drivers viewing area of screen.
