Report ID:	26,049,364	Version:	1
Created:	17 Nov 2025

Make:	Ford	Model:	Transit
Body Style:	Minibus	Year:	2011
Rego No.:	LAW186	Rego Expiry:	27 Feb 2026
WoF Expiry:	20 Mar 2026	Odometer:	205,765 Kms
Good No.:	26049364	VIN:	WF0DXXTTFDDBE24866
Next Service:	220,000kms	Service History:	No

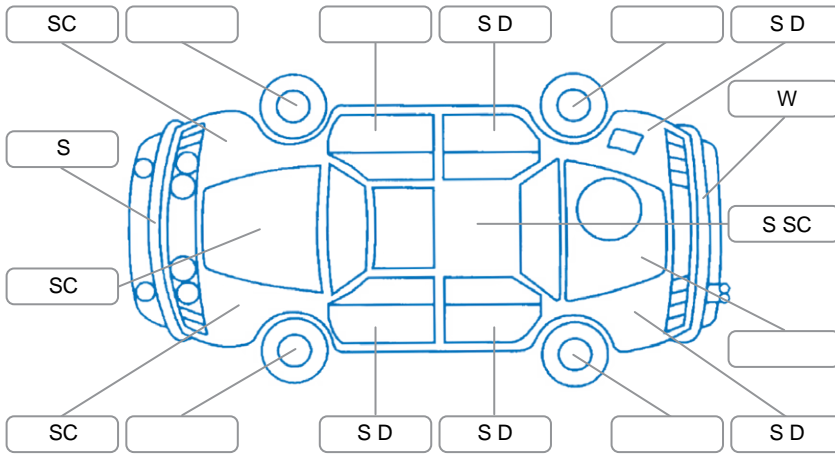
S = Scratch    R = Rust    C = Crack    \* = Decals    W = Significant scuffs  
D = Dent    PT = Paint defect    P = Pin dent    SC = Stone Chips

Note: some defects and blemishes may not be displayed in the diagram

12 seater. Minor stone chips on windshield. Left B pillar moulding is missing. Right sill front step paint is worn.
