Report ID:	26,051,079	Version:	1
Created:	17 Feb 2026

Make:	Mini	Model:	Cooper
Body Style:	Convertible	Year:	2007
Rego No.:	LJC765	Rego Expiry:	11 Feb 2026
WoF Expiry:	16 Sep 2026	Odometer:	156,318 Kms
Good No.:	26051079	VIN:	WMWRF32070TN02374
Next Service:	?	Service History:	No

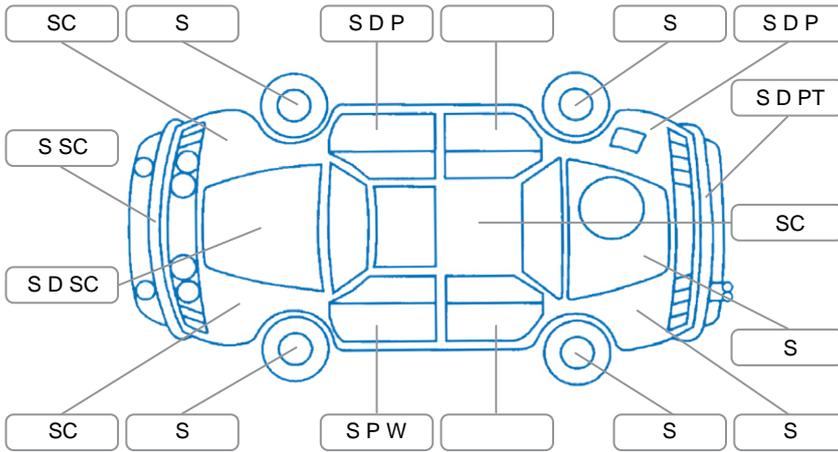
Note: some defects and blemishes may not be displayed in the diagram

Windscreen washer bottle is leaking. Bottom of left front guard flare is not fitting up to bumper correctly. Centre cap missing off left front alloy wheel. Radio aerial stalk is missing.
