Report ID:	26,068,992	Version:	2
Created:	26 Nov 2025

Make:	Subaru	Model:	Impreza
Body Style:	Hatchback	Year:	2013
Rego No.:	PTG460	Rego Expiry:	15 Mar 2026
WoF Expiry:	14 Jul 2026	Odometer:	91,625 Kms
Good No.:	26068992	VIN:	7AT0GF09X21015231
Next Service:	85,926 Kms	Service History:	No

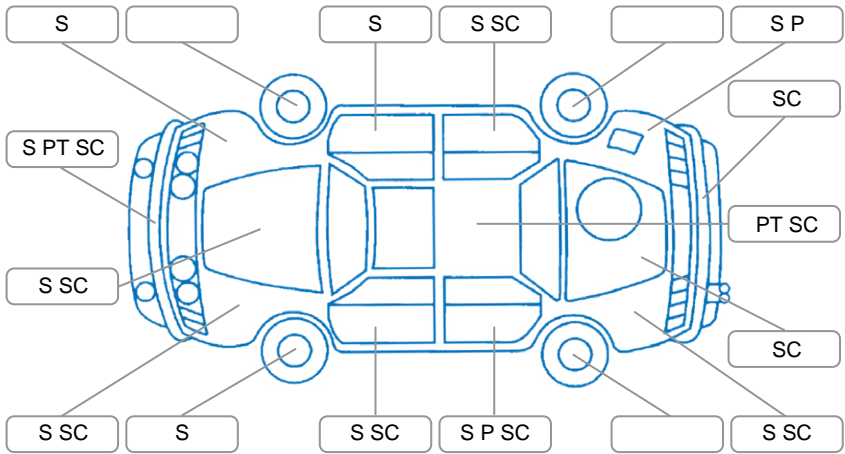
S = Scratch    R = Rust    C = Crack    \* = Decals    W = Significant scuffs  
D = Dent    PT = Paint defect    P = Pin dent    SC = Stone Chips

Note: some defects and blemishes may not be displayed in the diagram

Front grill is damaged.  
Tyre repair kit instead of spare wheel.
