| Report ID: | 26,132,191 | Version: | 2 |

| Make: | Mazda | Model: | Bt-50 |
| Body Style: | Utility | Year: | 2018 |

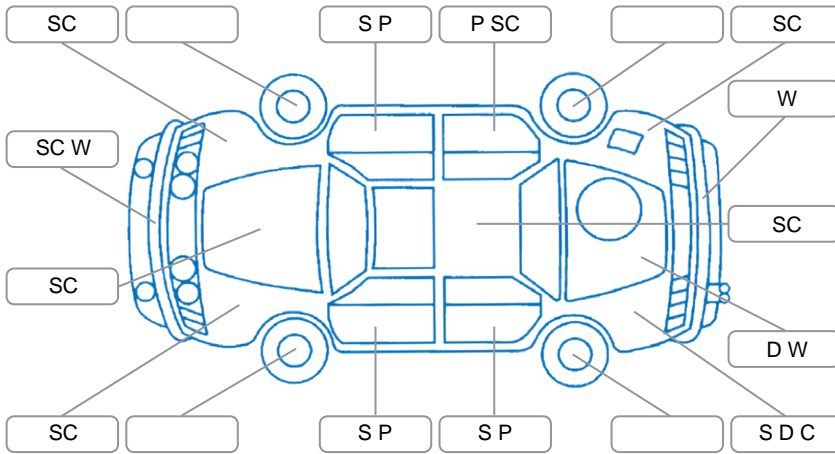
Note: some defects and blemishes may not be displayed in the diagram

Stone chips in windscreen and crack
 Dent on LH rear c pillar.
 Front bumper loose on both sides.
