| Make: | Mazda | Model: | Axela | Body Style: | Hatchback |
| Year: | 2009 | Registration: | MSF411 | Reg Expiry: | 13 Aug 2025 |
| VIN: | 7AT0C13JX20102513 | Next Service: | overdue | Service History: | Yes |

Body Inspection Comments

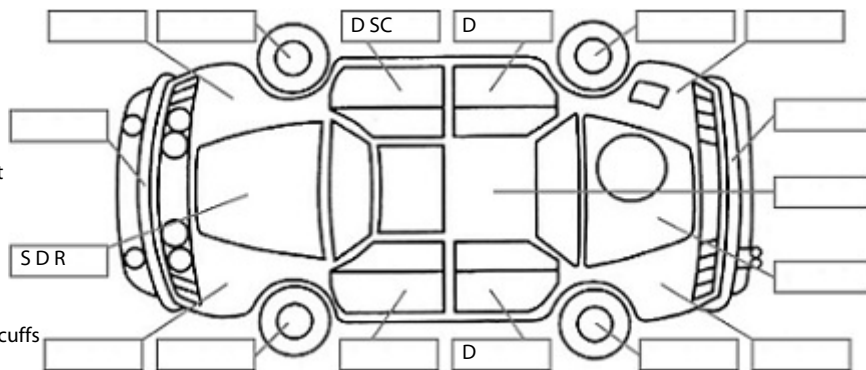
S = scratch
D = dent
R = rust
PT = paint defect
C = crack
P = pin dent
* = decals
SC = stone chips
W = significant scuffs

Note: some defects & blemishes may not be displayed in the diagram

Something rattling around in tailgate. Signs of water coming into the spare wheel well. Paint faded. Headlights faded. Stone chips in front screen. Rear bumper damaged
