Basic Condition Guide

•	Report ID:	27,159,603	Version:	1
	Created:	18 Nov 2025

JIIIEI			
Make:	Mitsubishi	Model:	Colt	
Body Style:	Hatchback	Year:	2007	
Rego No.:	JZS39	Rego Expiry:	03 Dec 2024	
WoF Expiry:	14 Nov 2026	Odometer:	109,286 Kms	
Good No.:	27159603	VIN:	7AT0CJ0XX16400609	
Next Service:	119,000	Service History:	y: No	
Note: This report is	not a warranty			
diagnostic testing un		een driven up to 50km/l	arts have not been dismantled or h from cold. The Vendor recommends a or an additional charge.	
Key

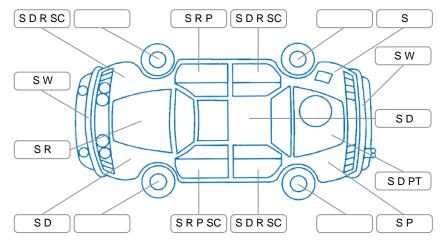
Note: some defects and blemishes may not be displayed in the diagram $\,$

Dents in Right Sill

Large Stone Chips Windscreen
