Basic Condition Guide

Report ID:	27,166,298	Version:	2
Created:	24 Nov 2025

Make:	Toyota	Model:	Hilux
Body Style:	Utility	Year:	2018
Rego No.:	LDE634	Rego Expiry:	22 May 2026
WoF Expiry:	03 Dec 2026	Odometer:	297,850 Kms
Good No.:	27166298	VIN:	MR0JA3DD000343053
Next Service:	307000 kms	Service History:	Yes

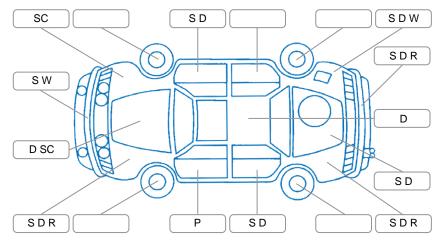
,				
S = Scratch	R = Rust	C = Crack	* = Decals	W = Significant scuffs
D = Dent	PT = Paint defect	P = Pin dent	SC = Stone Chins

Note: some defects and blemishes may not be displayed in the diagram

Rear impact damage. Headliner stains. Tailgate support strap loose RHS. Rear canopy window locks not working, latches installed. Right taillight hazy. High stop light cracked.
