Report ID:	27,564,861	Version:	2
Created:	30 Mar 2026

Make:	Renault	Model:	Trafic
Body Style:	Van	Year:	2021
Rego No.:	NBY581	Rego Expiry:	18 Sep 2026
WoF Expiry:	19 Jan 2027	Odometer:	77,559 Kms
Good No.:	27564861	VIN:	VF1FL0006L0817364
Next Service:	78,000 kms	Service History:	No

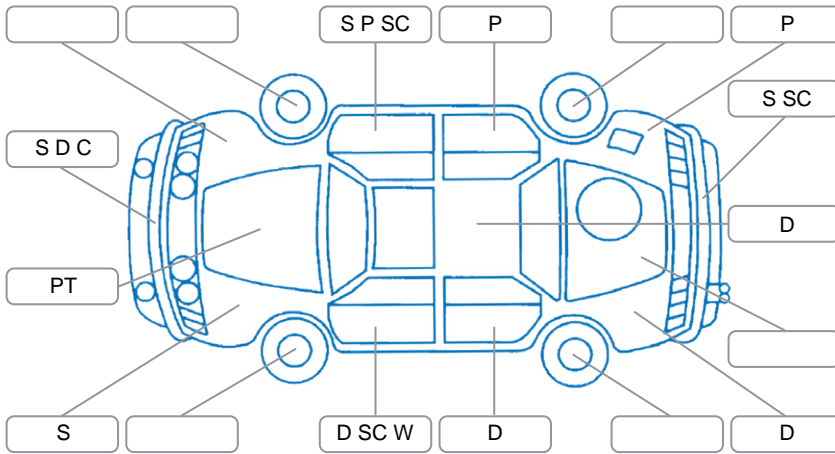
Note: some defects and blemishes may not be displayed in the diagram

Dents and scratches left B pillar, left wing mirror housing cracked  
 Left sill dents and gouge, left back door bent, right back door dents  
 Left front wheel centre cap missing, toolbox bolt missing, left tail light cracked  
 Scuffs cargo area inner frame and right wheel arch
