Basic Condition Guide

Make:	Toyota	Model:	Kluger
Body Style:	Wagon	Year:	2005
Rego No.:	NFE648	Rego Expiry:	22 Jun 2026
WoF Expiry:	24 Sep 2026	Odometer:	200,640 Kms
Good No.:	27793006	VIN:	7AT0H642X20160440
Next Service:	149,192	Service History:	Yes

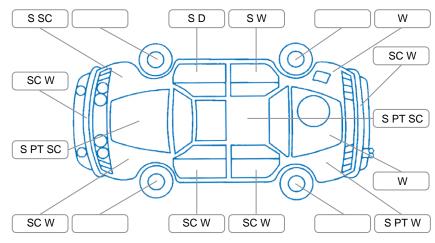
Note: some defects and blemishes may not be displayed in the diagram

RF headlight faded. Central locking & remote not operating drivers door lock and locking/unlocking when driving. Rear fold up seats not bolted in. LF door monsoon shield broken.
