Basic Condition Guide

•	Report ID:	27,797,285	Version:	1
	Created:	29 Nov 2025

Make:	Toyota	Model:	Hilux
Body Style:	Utility	Year:	1999
Rego No.:	XY2949	Rego Expiry:	26 Jan 2026
WoF Expiry:	25 Jan 2026	Odometer:	602,152 Kms
Good No.:	27797285	VIN:	JT732LNF200001025
Next Service:	611,000 km	Service History:	No

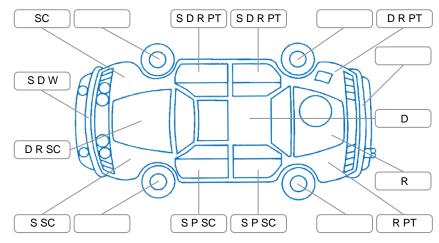
Note: some defects and blemishes may not be displayed in the diagram

Front indicator lens loose, R/H inner sill rusty, rear tray rusty, locking pin for tailgate broken,L/R tail light cracked,wing mirror caps missing,Windscreen chip out of cva,
