# **Basic Condition Guide**

•	Report ID:	27,808,714	Version:	3
	Created:	30 Nov 2025

Make:	Skoda	Model:	Octavia
Body Style:	Wagon	Year:	2016
Rego No.:	JPZ828	Rego Expiry:	02 Feb 2026
WoF Expiry:	10 Dec 2025	Odometer:	106,310 Kms
Good No.:	27808714	VIN:	TMBKJ7NE0G0057635
Next Service:	118,000km	Service History:	Yes

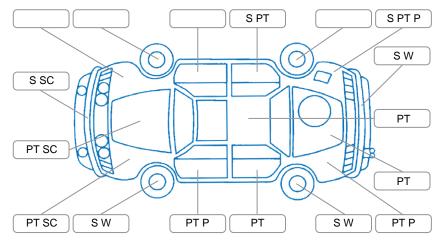
Note: some defects and blemishes may not be displayed in the diagram

Black overspray on the majority of exterior panels.
