# **Basic Condition Guide**

Report ID:	27,815,827	Version:	1
Created:	02 Dec 2025

Make:	Toyota	Model:	Landcruiser		
Body Style:	Utility	Year:	2014		
Rego No.:	NGB446	Rego Expiry:	17 Dec 2025		
WoF Expiry:	07 Nov 2026	Odometer:	241,332 Kms		
Good No.:	27815827	VIN:	JTELV71J300034282		
Next Service:	245,000kms	Service History:	Yes		
Note: This report is not a warranty  This report is a guide only. Consideration is made for age and mileage. Parts have not been dismantled or diagnostic testing undertaken. The vehicle has been driven up to 50km/h from cold. The Vendor recommends a full mechanical inspection prior to purchase and this can be arranged for an additional charge.

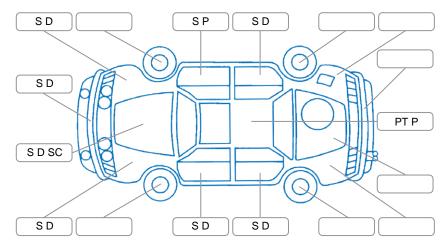
Note: some defects and blemishes may not be displayed in the diagram

Grille broken. Aerial broken.

Chipped windscreen.

Running boards damaged.

Right headlight cracked, moisture inside.
