Basic Condition Guide

Make:	Ford	Model:	Fiesta
Body Style:	Hatchback	Year:	2007
Rego No.:	EDW581	Rego Expiry:	31 Dec 2025
WoF Expiry:	17 Oct 2026	Odometer:	163,294 Kms
Good No.: 27817854		VIN:	WF0HXXGAJH7T57296
Next Service:	167,200kms	Service History:	No

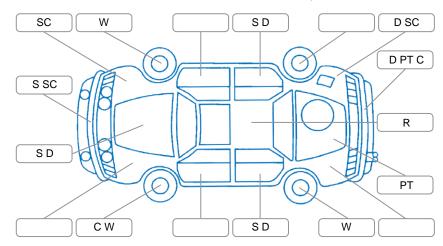
Note: some defects and blemishes may not be displayed in the diagram

Left front windshield corner cover is missing. Right door mirror housing is cracked. No parcel tray. Right rear edge of roof is rusty. Water in High mount stop light and not operating. Right brake light is not operating. Aerial is missing .
