•	Report ID:	27,823,654	Version:	1
	Created:	03 Dec 2025

Make:	Ford	Model:	Territory
Body Style:	suv	Year:	2012
Rego No.:	KZT958	Rego Expiry:	26 Mar 2026
WoF Expiry:	26 Nov 2026	Odometer:	176,863 Kms
Good No.:	27823654	VIN:	6FPAAAJGATCK79354
Next Service:	186000	Service History:	No

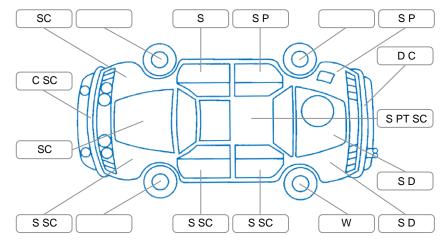
Note: some defects and blemishes may not be displayed in the diagram

Hood lining sagging, R/F Door window not working keeps falling Down , Rear console Tray Broken,
