| Report ID: | 27,856,856 | Version: | 1 |

| Make: | Subaru | Model: | Legacy |
| Body Style: | Wagon | Year: | 2012 |

Body Inspection Comments

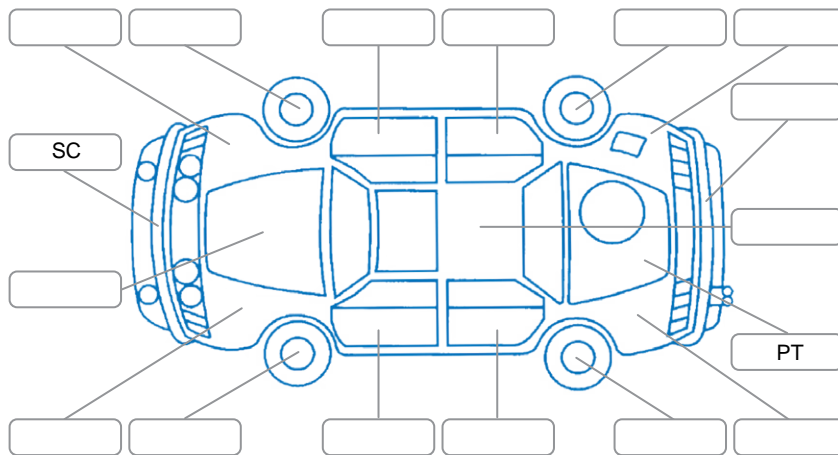
S = Scratch R = Rust C = Crack * = Decals W = Significant scuffs
D = Dent PT = Paint defect P = Pin dent SC = Stone Chips

Note: some defects and blemishes may not be displayed in the diagram
