| Make: | Fiat | Model: | 500 |
| Body Style: | Hatchback | Year: | 2012 |

Body Inspection Comments

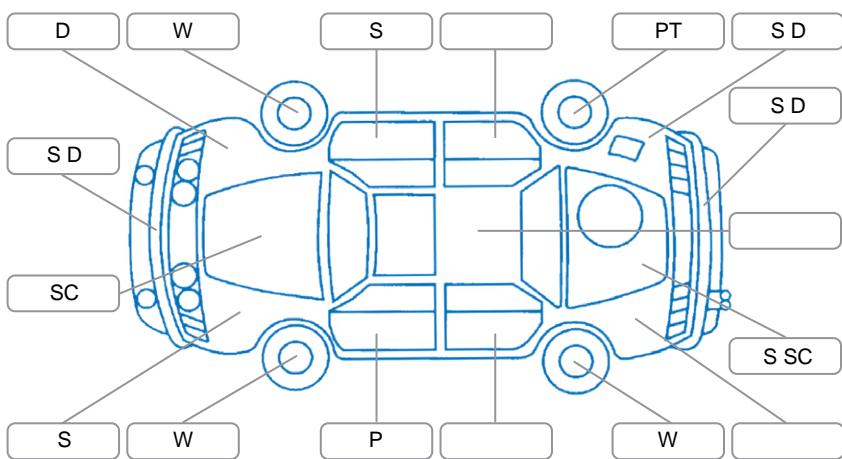
S = Scratch R = Rust C = Crack * = Decals W = Significant scuffs
 D = Dent PT = Paint defect P = Pin dent SC = Stone Chips

Note: some defects and blemishes may not be displayed in the diagram

Windscreen stone chip
 Headlights faded
 Rear bumper tow eye cover missing
